TURNAGAIN UNITED METHODIST CHURCH

Internal Design of Existing Three-Pass High Efficiency Industrial Type Boiler

Subject: Existing Three-Pass Boiler

## BOILER CONDITION & REVISED RECOMMENDATION

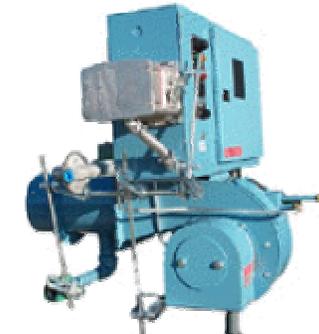
Low/High/low Burner

Discussions by all examined the advantage for TUMC to install a new low/high/low fire gas burner. The new burner would reduce the number of on/off cycles and the amount of time the burner spends firing at full rate. This provides optimum load matching, e.g. Building BTU heat loss during warm weather 300,000 btu (low fire) and cold weather 600,000 btu (high fire).The burner will stay on for a greater length of time at the lower firing rate but saves a significant amount in natural gas costs. Including incidentals or other problems an installer may encounter, a new low/fire/low gas burner could be as much as \$7,500.00 installed.
